Neligh, Nebraska Blight and Substandard Study - Area 2

PURPOSE OF THE BLIGHT AND SUBSTANDARD STUDY

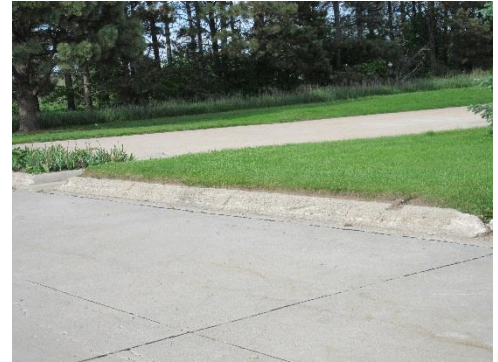
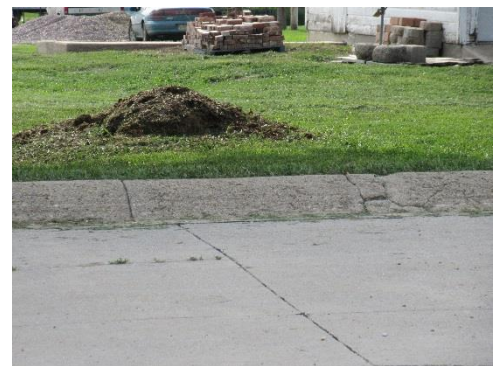
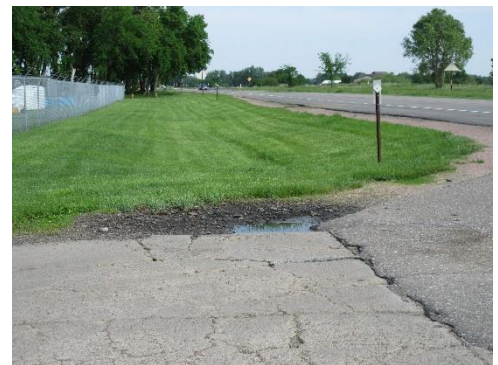
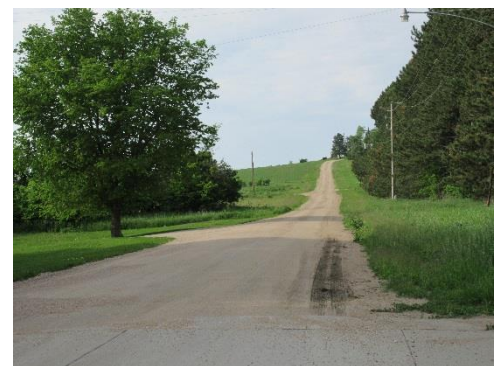
Deteriorating is defined as any evidence of breakage/chipping away at joints and horizontal surfaces. In addition, any heaving or breakage along the gutter portion of the system.

The photos to the immediate right show some of the deteriorating conditions found within the study area.

Due to the large amount of deteriorating and missing curb and gutter, the curb and gutter condition would be a direct contributing factor.

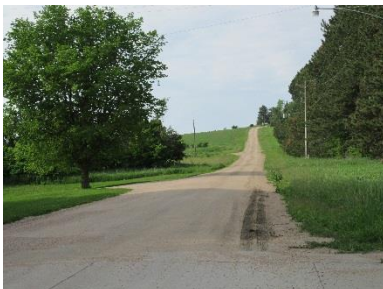
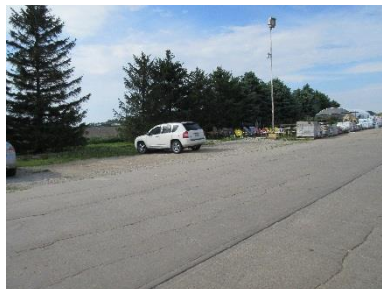
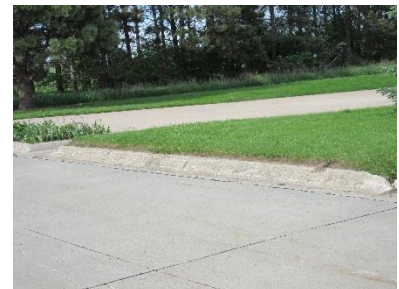
Deteriorating is defined as any evidence of breakage/chipping, heaving, major potholes, spawling finished surface, and materials lose at joints.

The photos at the bottom show some of the deteriorating conditions found within the study area.

Due to the large amount of deteriorating or gravel surfacing, the street conditions are a direct contributing factor.

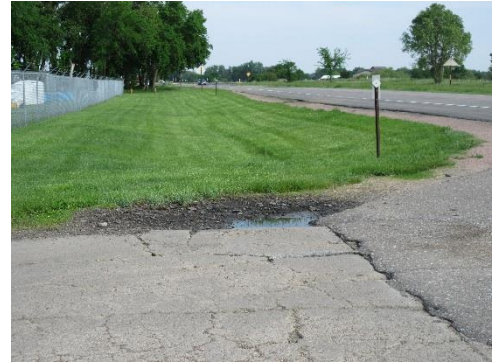
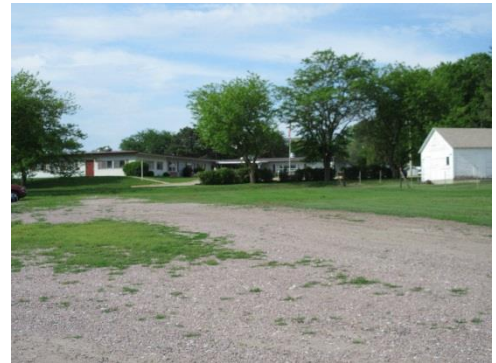
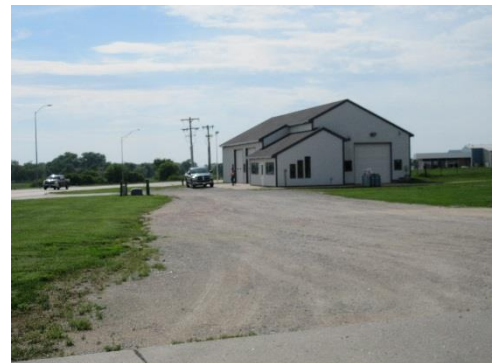
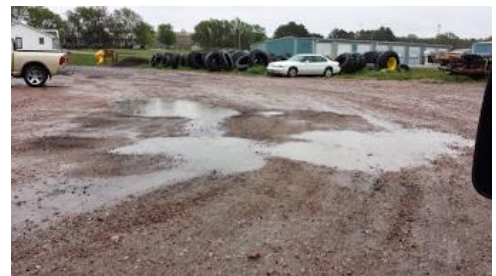
A large portion of the properties have gravel/dirt drives and parking lots. These properties create several issues within a community including:

- Dust conditions during dry periods
- Ruts from heavy equipment
- Water holes during wet periods

Some properties have paved/improved parking areas and drives were found to be in a state of deterioration. Several of the hard surfaced lots, as seen on the right are in considerably poor condition.

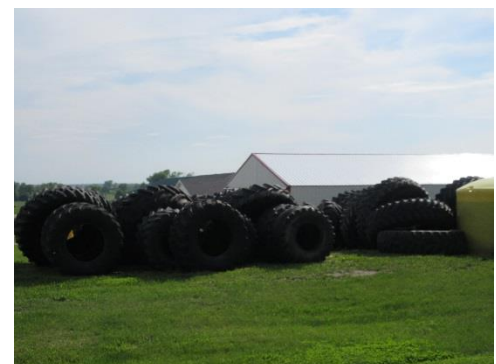
There are locations where property owners/businesses are leaving merchandise out in the open. In one case the business sells large truck and tractor tires. However, the lot where their merchandise is being stored is not secured by a fence of any type. This condition creates an unsafe condition if kids or others were wondering around in the dark.

In addition, the implement dealer in the study area stores older, sometimes rusting, machinery back behind the business; this back area fronts onto North "V" Street. Some of these pieces are secured; while, some are not.

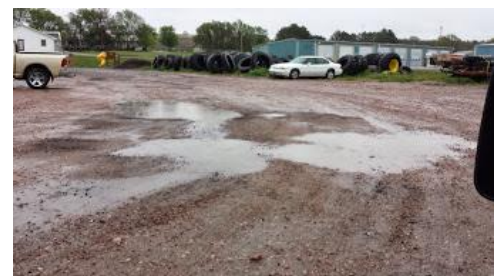
The study area is in a part of Neligh that is relatively flat and water does not appear to drain well. In addition, the majority of the area is designed to drain water via ditches (rural section). Due to these particular conditions, this part of Neligh can see large amounts of standing water during and after a rain event.

Standing water from poor drainage can be a catalyst for health issues like West Nile due to the potential mosquito breeding during the summer months.

Standing water during a recent rain event

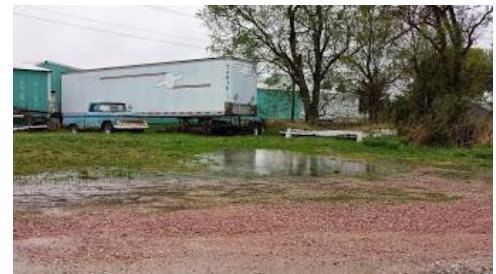
Standing water during a recent rain event

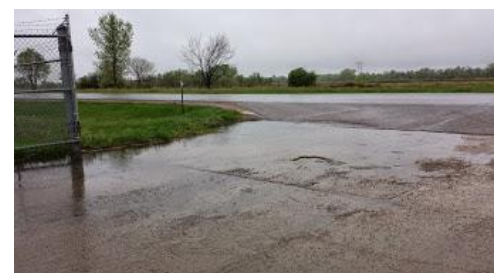
Standing water during a recent rain event
